FINAL REPORT  
IHR-513  
CRACK CONTROL  
OF  
POZZOLANIC BASES

David L. Lippert, P.E.  
Technical Services Engineer  
and  
Amy M. Schutzbach, P.E.  
Design Technology Engineer

Illinois Department of Transportation  
Bureau of Materials and Physical Research  
Springfield, Illinois

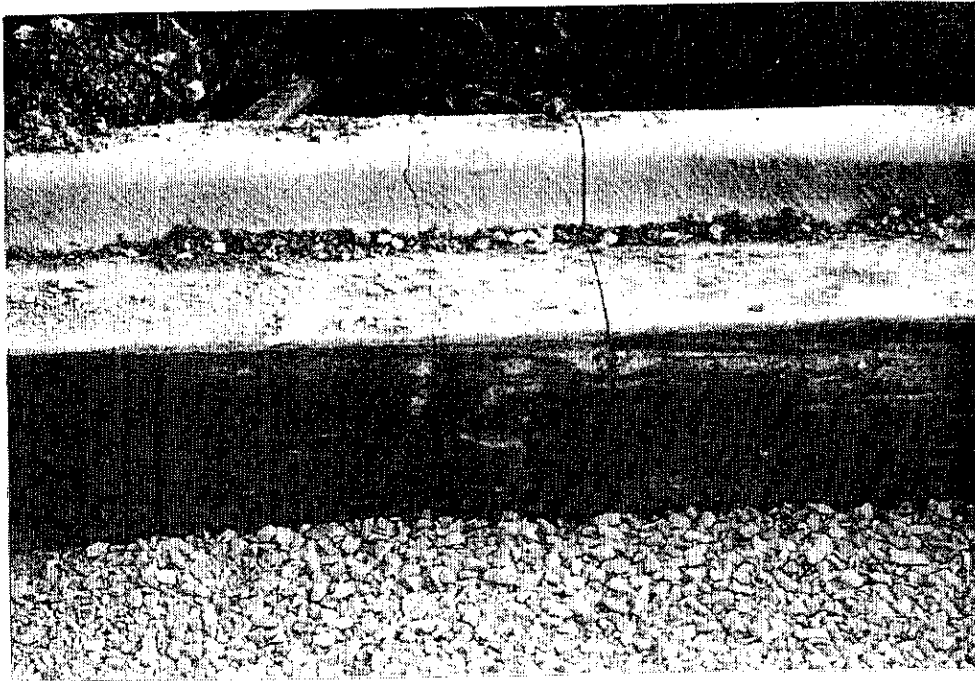
The westbound curb and gutter were formed, placed and then sawed at intervals to match the base joints in the experimental section. In the control section, the curb was sawed every 40 feet. The eastbound curb and gutter were slip formed. Joints were sawed to match the location in the westbound curb. Although the sawing was accomplished within 24 hours of placement, an occasional shrinkage crack developed very close to the saw cut, as shown in Figure 5.

Figure 5: Shrinkage crack next to joint in curb.

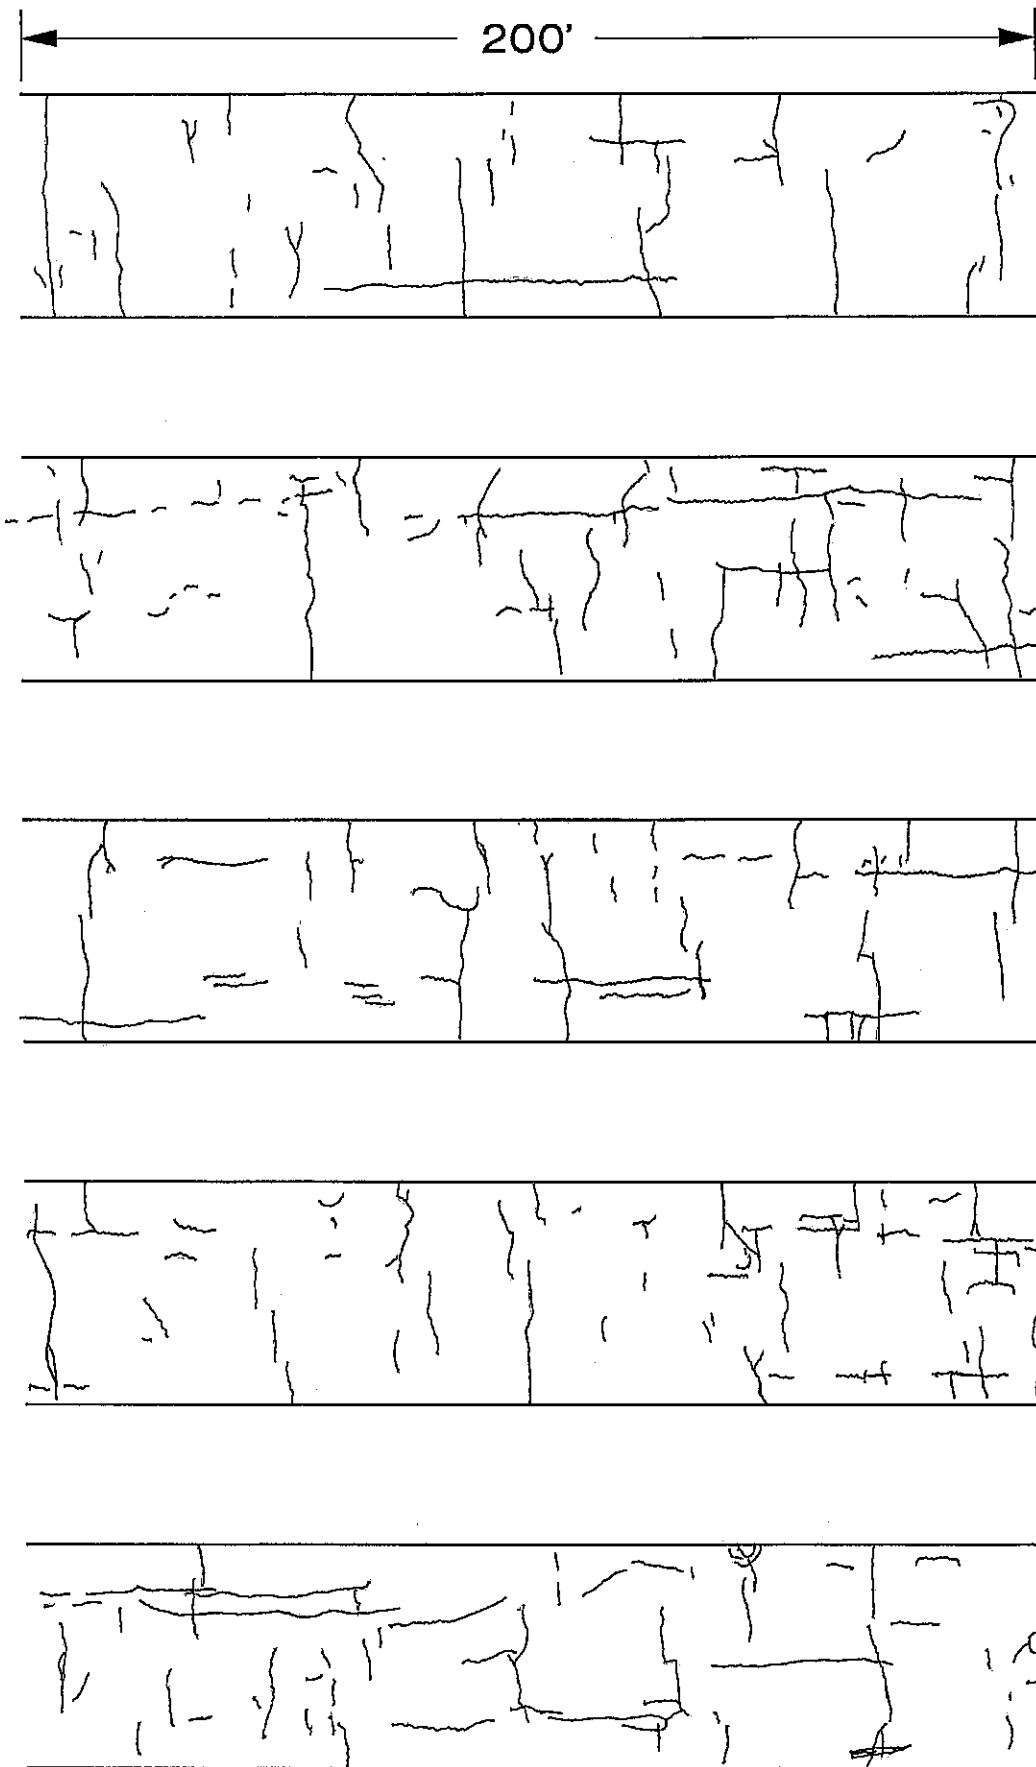
Ogden Avenue Control Section: The reflective cracks in the control section without joints have occurred at random intervals. While most of the cracks are perpendicular to the curb line, they rarely extend across the 55-foot pavement at one location. Instead, a series of shorter cracks, often offset by several feet, span the pavement. The cracks are ragged in appearance, very similar to those of Designs A and C. Figure 10 is a plan view of the crack locations in the control section after four years in service.

FIGURE 10: Crack Pattern in Control Section on Ogden Avenue

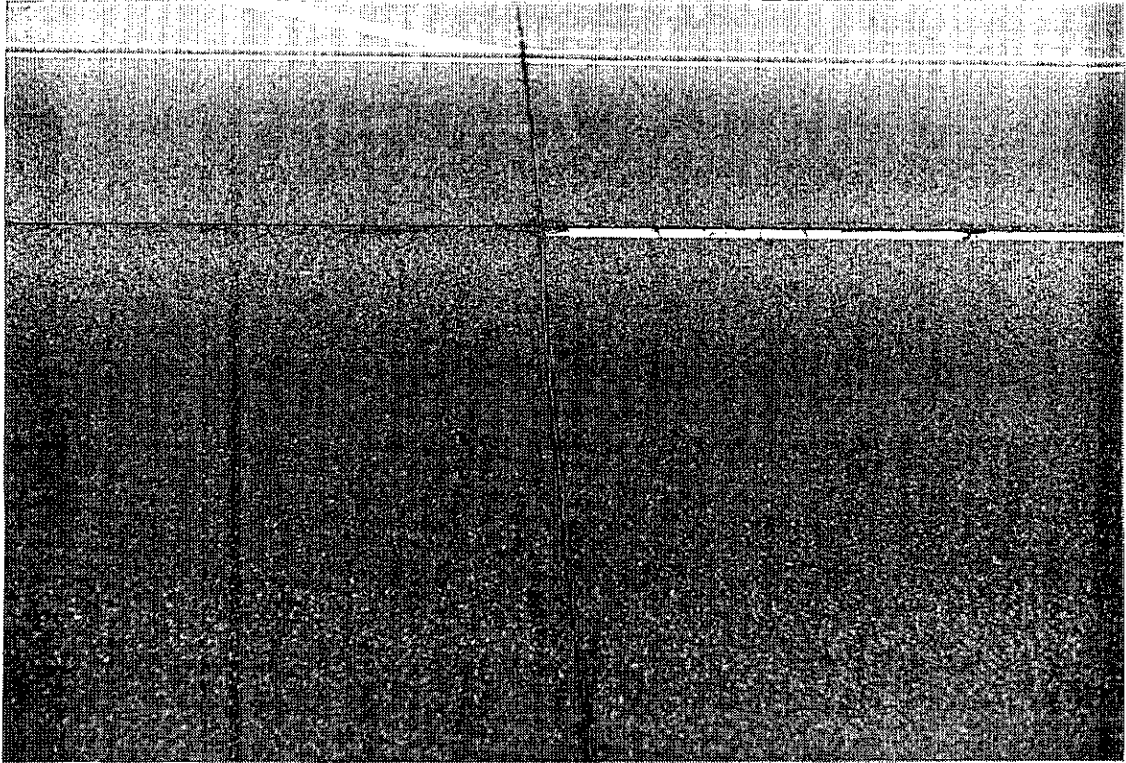
Figure 11: Sealant pulling away from walls of Design B joint with 40-foot spacing.

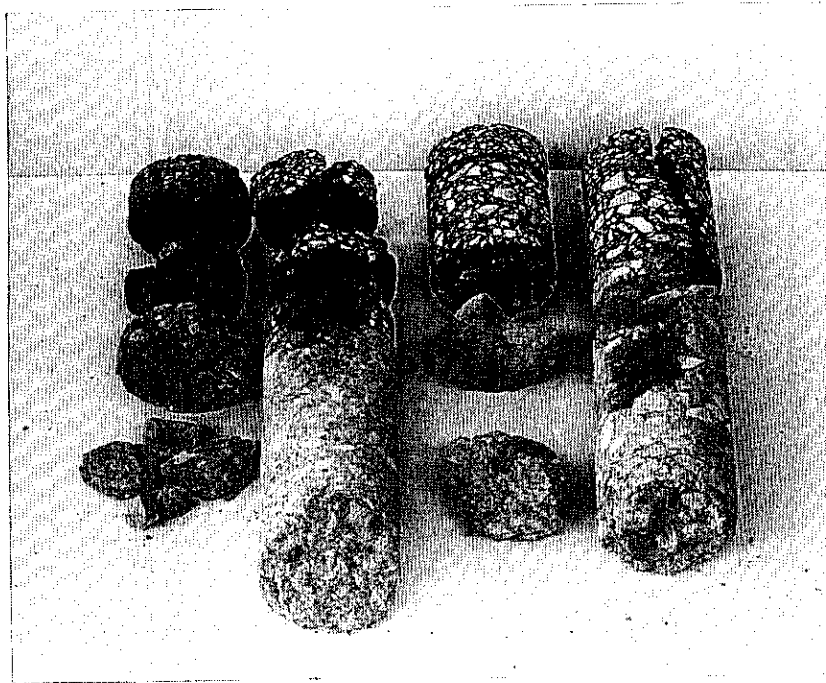
In general, the cores taken at naturally occurring cracks in the control section were in poor condition, as evidenced in

Figure 12. The bituminous concrete shows ragged cracks and the LFAM base course, where recoverable, had begun to disintegrate. Each core hole was also inspected after the coring was complete. In each case the hole appeared to contain sound material with the core hole walls being smooth except for the bottom 1 inch of the hole. In contrast, the cores in Figure 13 were taken from the center of "slabs", between joints and cracks, and show fairly sound and well compacted base material. The crack in the base course of the core on the right appears to have been caused by the roller during base course compaction. The surface of the base of this core is very uneven, and excess rolling to achieve compaction may have initiated the crack.

Figure 12: Cores taken at naturally occurring cracks in control section on Ogden Avenue.

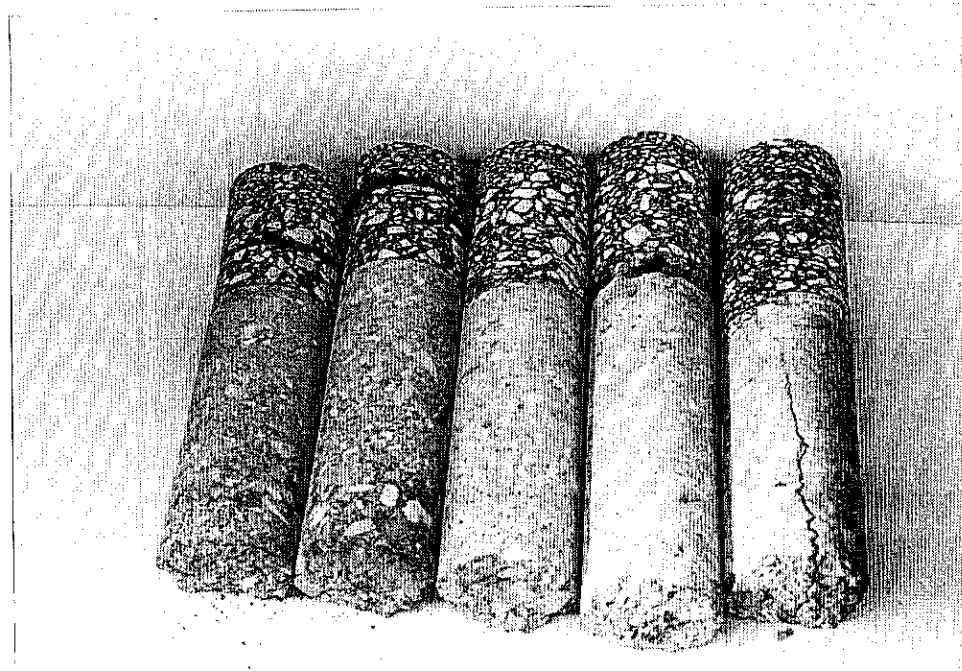
A limited amount of strength testing was done on the cores and the results are listed in Table 5. Test results of cores taken from the center of "slabs", between joints and cracks, show the difficulties in obtaining compaction when the base course is placed in a single lift as the strength decreases with depth. Compressive

Figure 13: Cores taken between joints and cracks on Ogden Avenue.

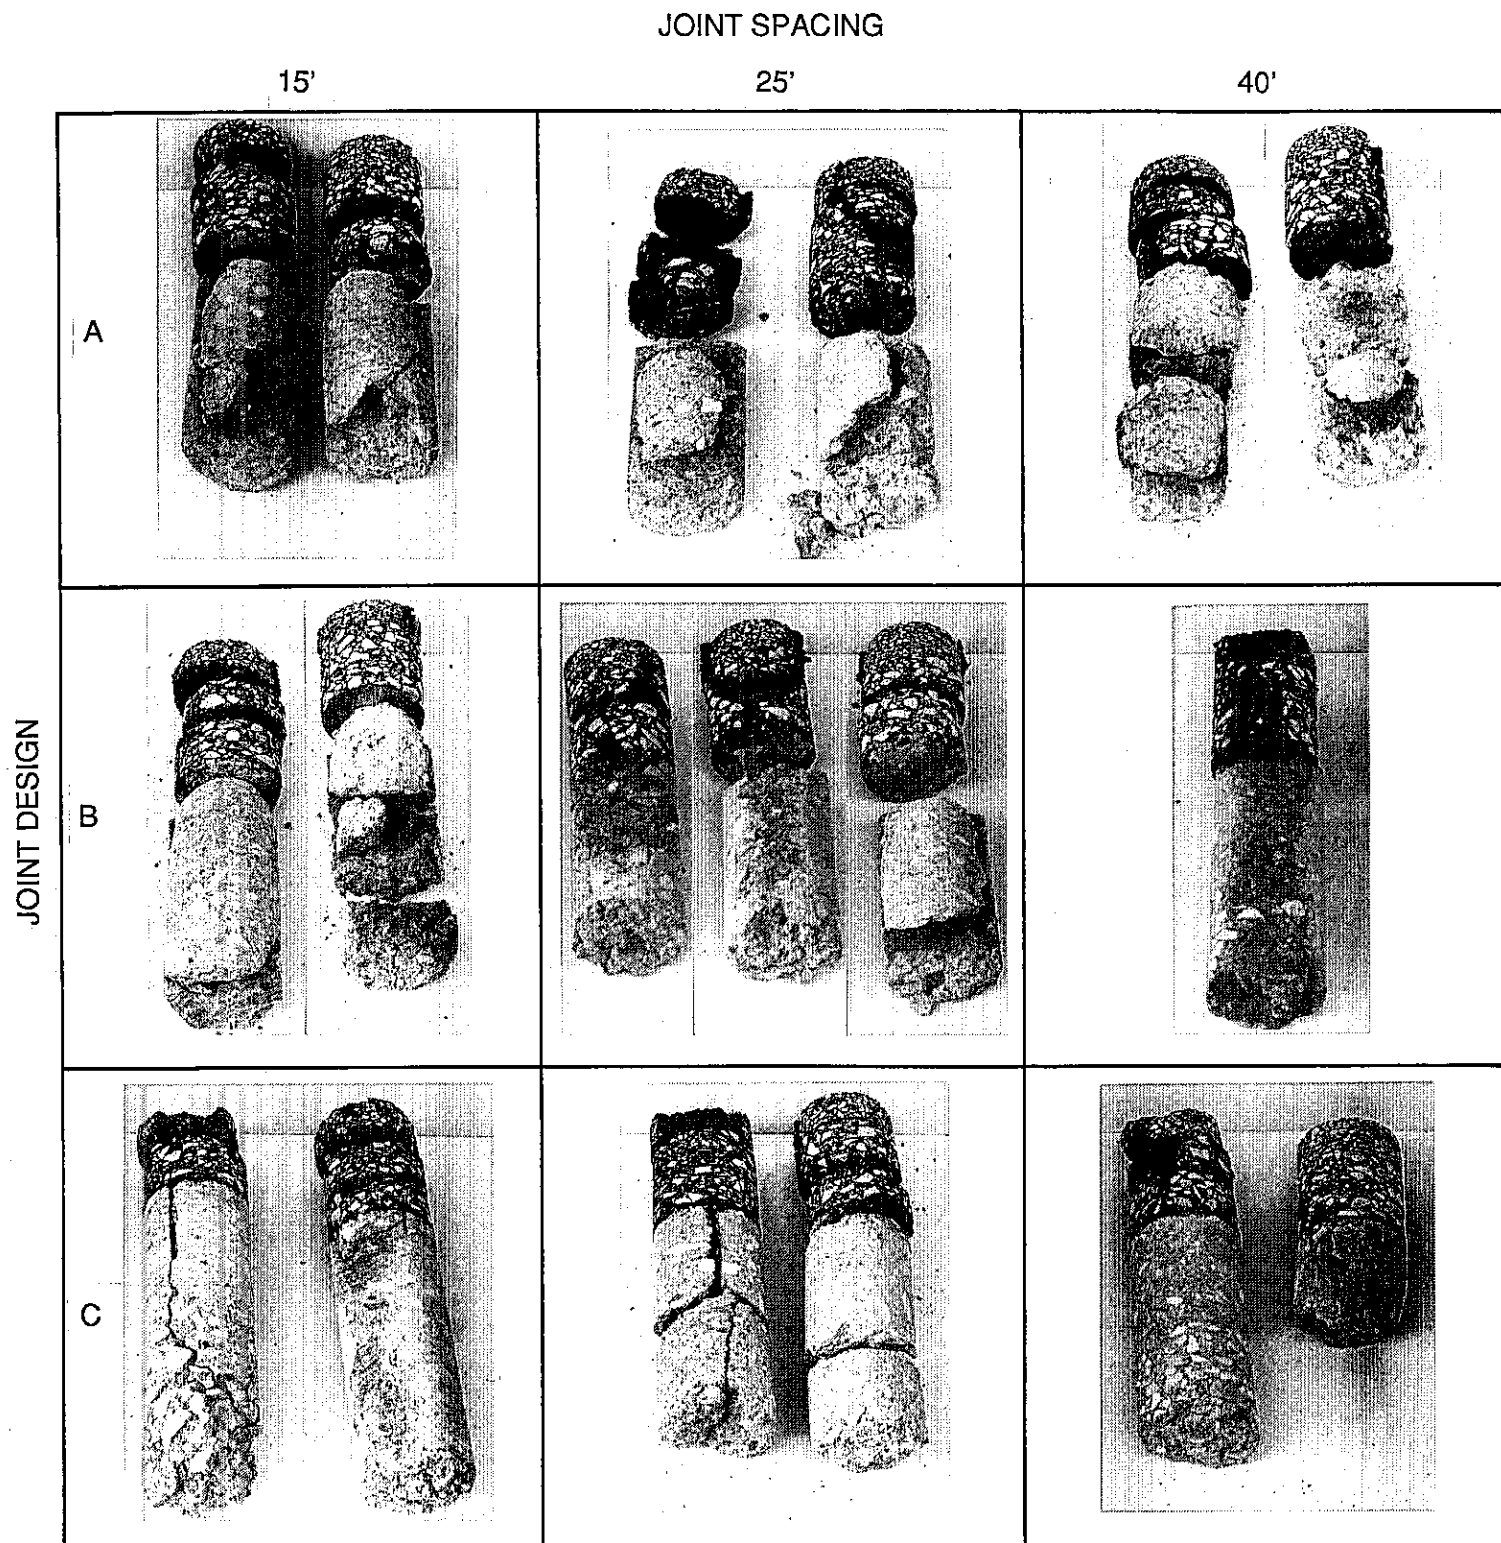
Figure 14 shows a matrix of the recovered cores grouped by joint designs and spacings. A comparison of the cores shows that Design B was the most successful at protecting the bituminous surface course by controlling the quality of cracking. The sealed surface joints do not detract from the pavement's appearance. The sealed joints also retarded the ravelling process as shown in Figures 15 and 16. The reflective cracks appearing above the base joints in Designs A and C are just that--cracks. The location has been controlled but the ragged appearance of the reflective cracks is not aesthetically pleasing.

In terms of protecting the LFAM base course, Design C appears to have been the most successful. The ragged surface cracks of Design A and the uncontrolled cracks in the control section allow water and deicing salts to penetrate to the LFAM base. This severe freeze-thaw environment results in disintegration of the base as evidenced by a less than complete core recovery. While the surface cracks in Design C do allow some water and deicing salts to penetrate, the geotextile fabric protects the LFAM base course to some degree.

Figure 14: Matrix of cores recovered from Ogden Avenue.

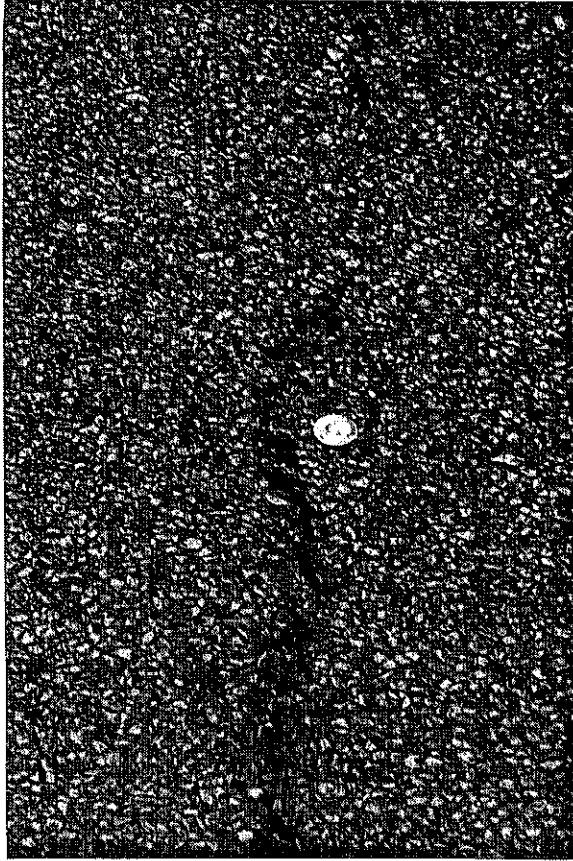
It was found that all joints allowed moisture and salts to enter the pavement. At the edge of the moist crack, white deicing salts had crystallized. Unfortunately, this was typical of all joints viewed. A visual survey showed that Joint Design A had slightly more salt accumulated than Designs B, C, and the control section. Overall the base appeared sound in the joint and crack areas regardless of joint design.

Figure 15: Joint Design A  
with 25' spacing

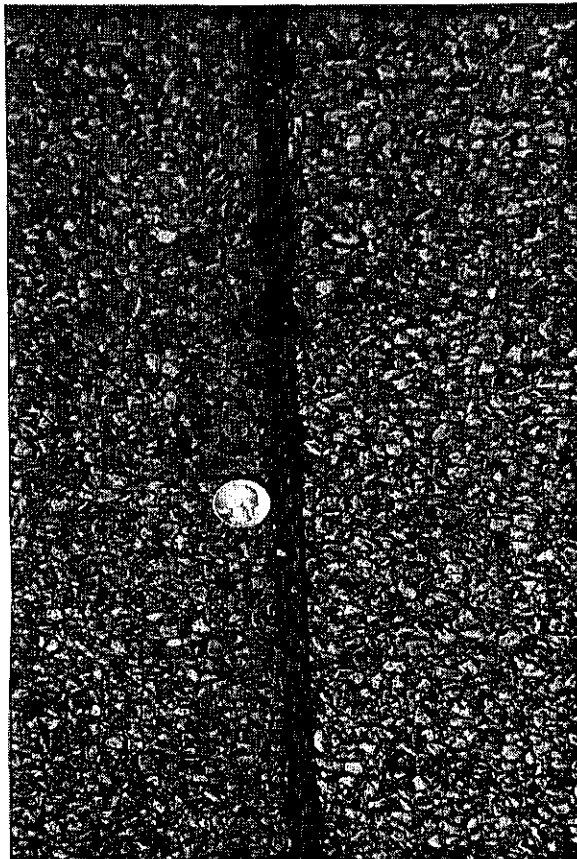
Figure 16: Joint Design B  
with 25' spacing
